MAN
TG-A
ALL ENGINE MODELS
2002-

PROBLEM PREMATURE OIL COOLER FAILURE, INTERNAL BURST > LEAKAGES

OIL PRESSURE RELIEF VALVE FAILURE > LEADS TO EXCESSIVE LUBRICANT PRESSURE AND OIL COOLER DAMAGE

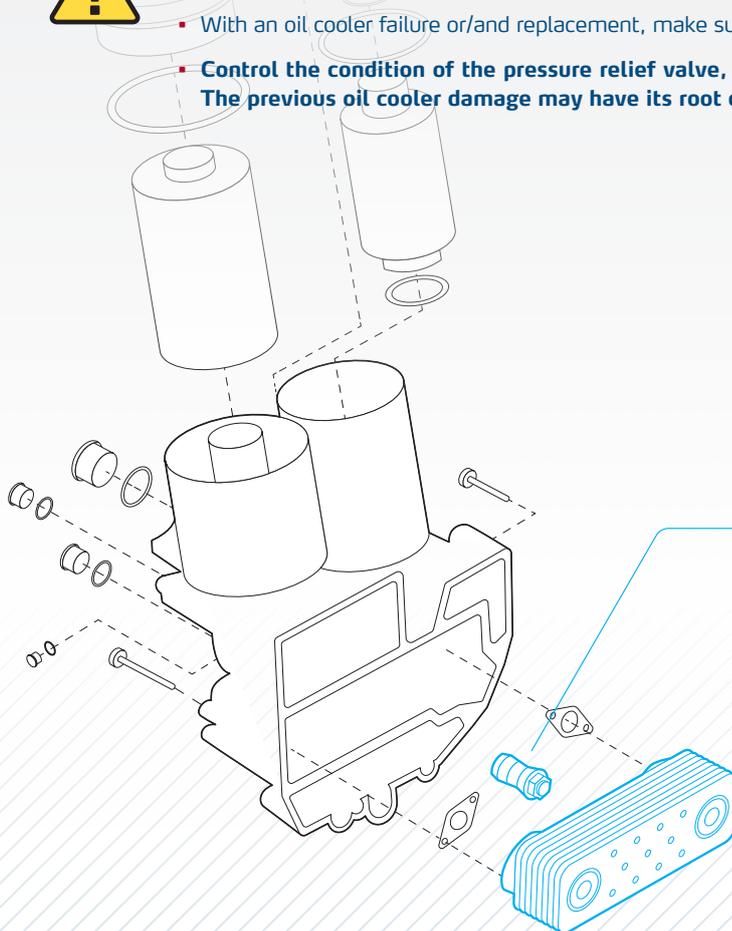
Lubricant mixed with coolant, seen on the oil cooler outlets. One of the most common outcomes of lubricant overpressure and internal bursting of the oil cooler.

Pressure Relief Valve location in the vehicle oil filter/oil cooler assembly. OE 51.05000-7098

- Replace oil and oil filter regularly and according to the vehicle's maintenance schedule.
- Ensure that the lubrication system is clean.
- With an oil cooler failure or/and replacement, make sure to measure the pressure of the lubricant in the system
- **Control the condition of the pressure relief valve, clean and replace it whenever a failure is suspected. The previous oil cooler damage may have its root cause in the valve failure.**
