AUXILIARY WATER PUMP

VW GROUPS 2012-2017 VEHICLES
USING THE 2.0 TSFI ENGINE

PROBLEM MOISTURE IN MOTOR ENCLOSURE

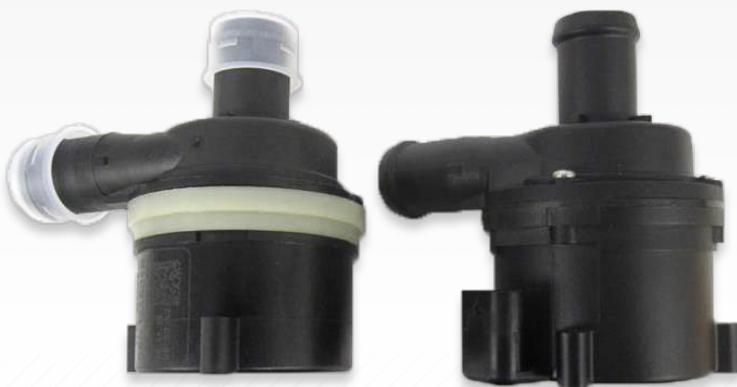
A water pump issue, which could result in water pump failure, has been identified on cars develop by the VW Group between 2012 and 2017 using the 2.0 TSFI engine. These water pumps has been developed with a plastic weld to attach the pump cover to the motor housing. This plastic weld is not effecient in preventing moisture from collecting inside the motor enclosure, as the plastic weld method can have porosity. This could potentially cause an electrical short in the auxiliary water pump and cause it to malfunction.

Here you see (left) an electric OE water pupmp that is only combined with a plastic weld. On the other side (right), you can see the aftermarket version where the housing is attached with a rubber seal on top of the weld to protect from moisture,

To ensure that no moisture reaches the motor unit, it is reccomended that all OE water pumps for these vehicles are replaced with a high quality aftermarket part. These parts must be covered with a rubber seal around the weld and clamped with stainless stell screw. This is a design that is commonly found on all other OE auxiliary pumps.

This design ensures that no moisture can enter the the inside of the motor enclosure, thereby protecting the auxiliary water pump from electrical shorts due to moisture.

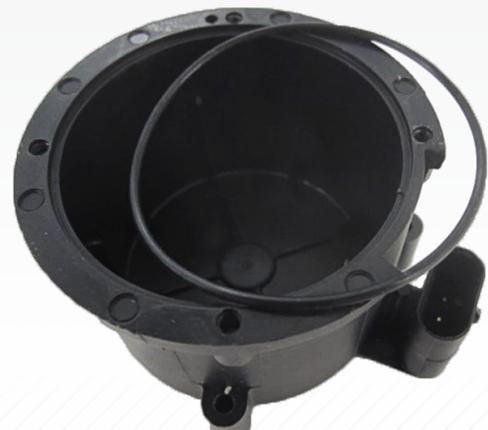
The aftermarket version of the electric water pump has additional protection in the form of an O-ring on the house attachment.
