THEME: TURBO AND TURBOCHARGED SYSTEM ENGINE LUBRICATION SYSTEM

PREVENTING TURBO LUBRICATION FAILURES

COMMON TURBO LUBRICATION FAILURES

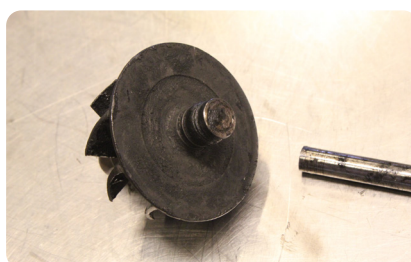
Insufficient lubrication: Broken shaft caused by lack of lubrication. The high rotation speed and frictions within the moving parts have caused the temperature to increase extremely, the shaft to warm up, and ultimately break by seizing.

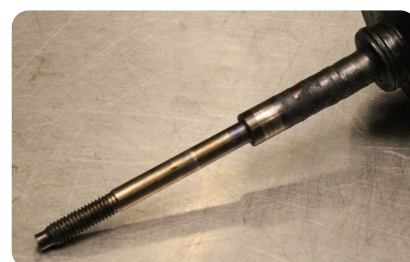
Insufficient lubrication: The surface of the turbo shaft is black and carbonized. Insufficient oil supply have caused overheating at first, thus making the steel color change. The blueish-to-yellowish color temperature is a heat tint caused by overheating of the shaft steel. Next, the remaining oil will start coking on the surface, making the black sinters.

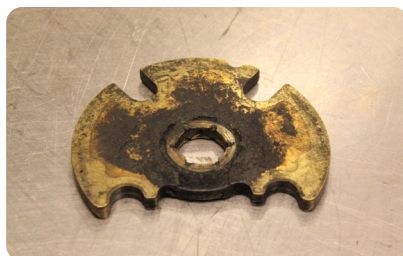
Insufficient lubrication: Oil coking on the thrust bearing – failure provoked by insufficient lubrication that caused overheating.

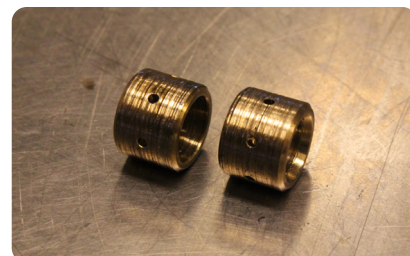
Oil contamination: The clearly visible grooves on the journal bearing surface arise from frictions and excessive material abrasion provoked by impurities in the oil. Despite the presence of oil, shaft of this turbo get seized.

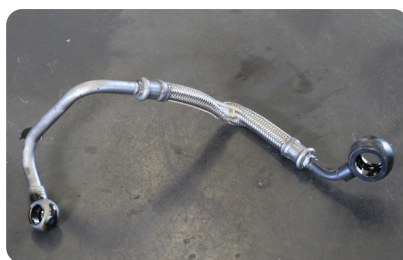
Oil supply disturbance: Oil feedline deformation caused by careless installation. The line is tight but the deformation caused oil thus shortages in lubricant supply to the turbo.

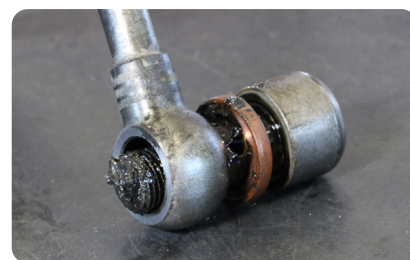
Oil supply disturbance: Severe oil contamination (sludge/carbonizing) caused oil feed line restrictions visible on banjo fitting.
