**VAG**

**2005-2015**

**A/C not working, compressor centre bolt presses itself out**

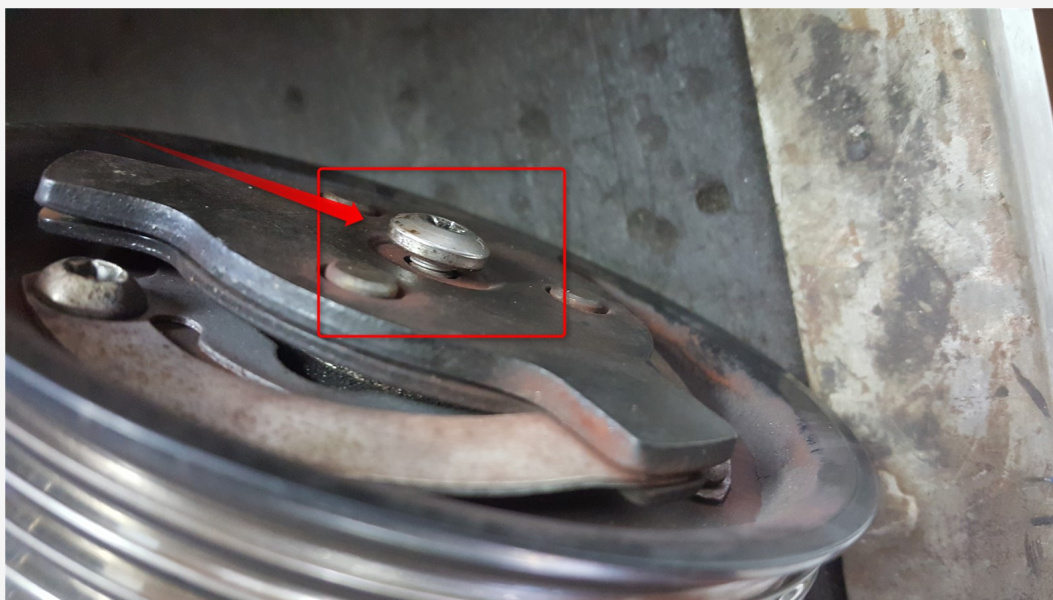
**In VAG models with variable A/C compressor, the centre bolt in the pulley of the A/C compressor often comes off.**

**This may e.g. happen when the pump drive has to transfer power higher than 110-120 Nm. In some cases, the woodruff key in the shaft may be ruined as well.**

**This problem often occurs when the A/C system pressure is too high due to too little oil in the system, or if the oil has been diluted by too much or a wrong type of leak detection agent, or if the condenser and/or the drier filter is faulty/clogged.**

**Regarding leak detection agent, we recommend to use an oil-based leak detection agent in connection with this type of compressor.**

**In connection with compressor replacement, always check the condenser and drier filter thoroughly and possibly clean them, if necessary replace them.**

**In rare cases, this fault also occurs if the electric control valve (ECV) in the compressor is faulty. This component is part of the compressor.**
