BULLETIN

MAKE / MODEL:
Mercedes-Benz

SUBJECT / SYMPTOM / TROUBLE CODE:

A/C system has faults, fault codes for control motor to swirl valves in A/C system, fault codes possibly stored

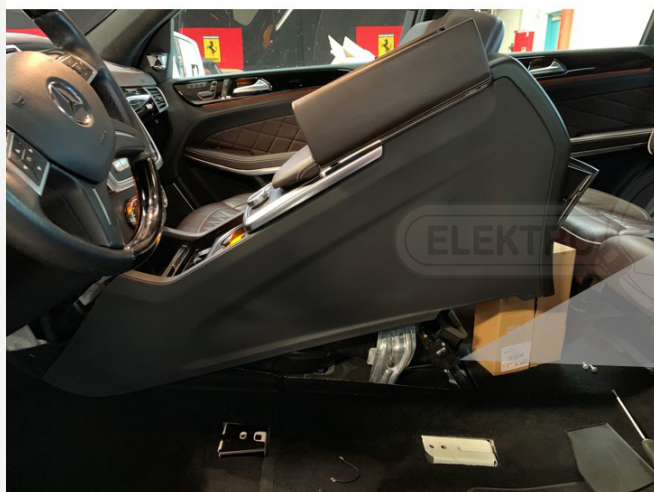
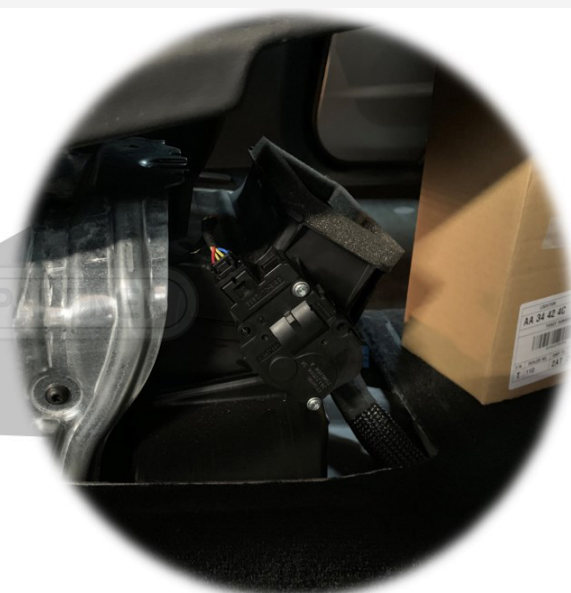
In this example, the fault was in the stepper motor, which controls the air to the passengers in the rear seat.

To locate the motor that reads out the fault on Linbus, you have to disconnect the connector to the stepper motor one at a time while monitoring the Linbus signal with an oscilloscope.

Often, Linbus works when you disconnect the connector from the faulty stepper motor.

If you connect the connector to the faulty stepper motor, the Linbus signal disappears.

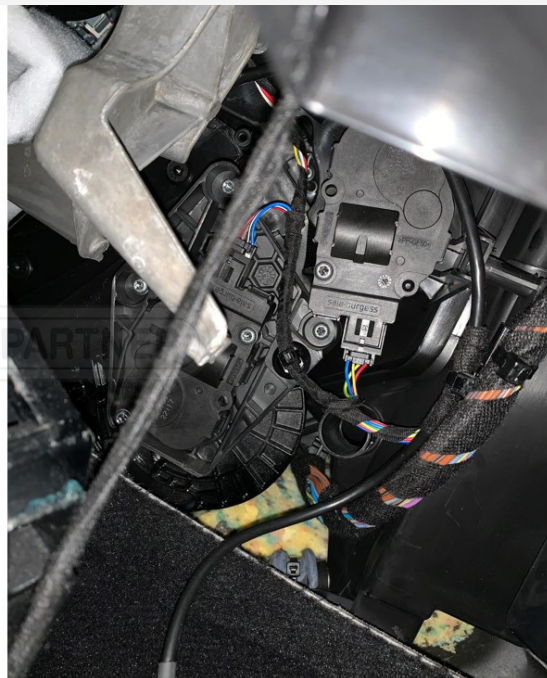
In the above picture, the Linbus signal is flawless.
If necessary, see bulletin 5253 regarding general control of Linbus signal.

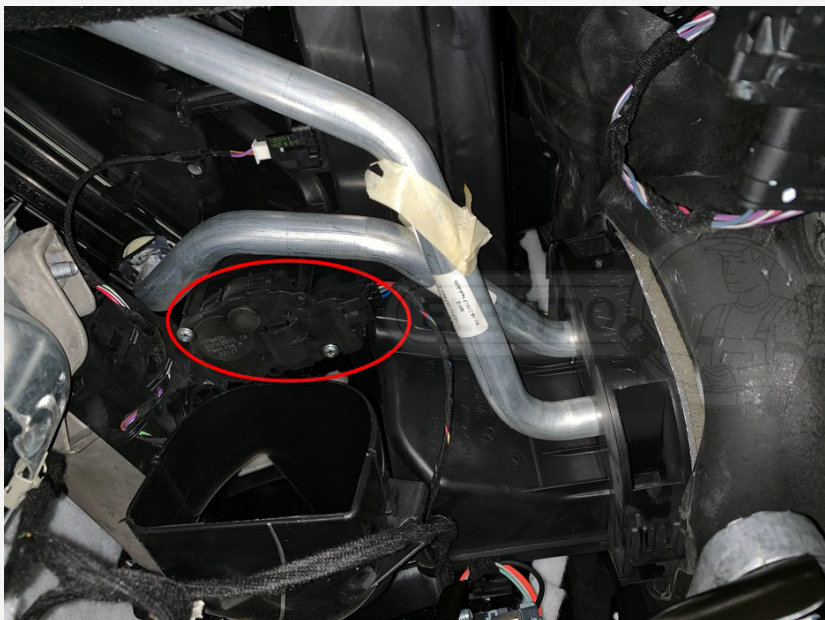
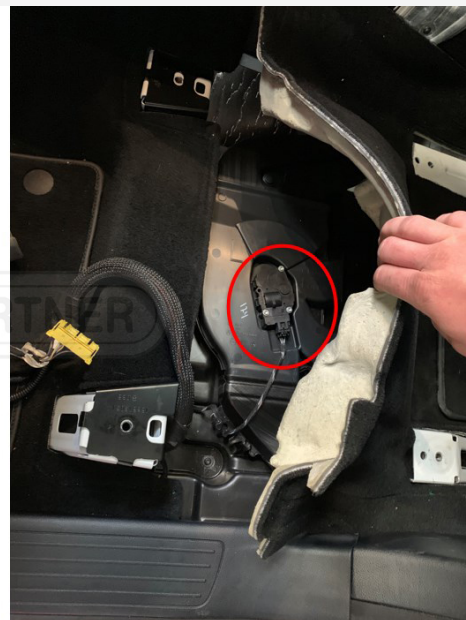
It is difficult to locate some of the stepper motors.
Here are some examples of the location.

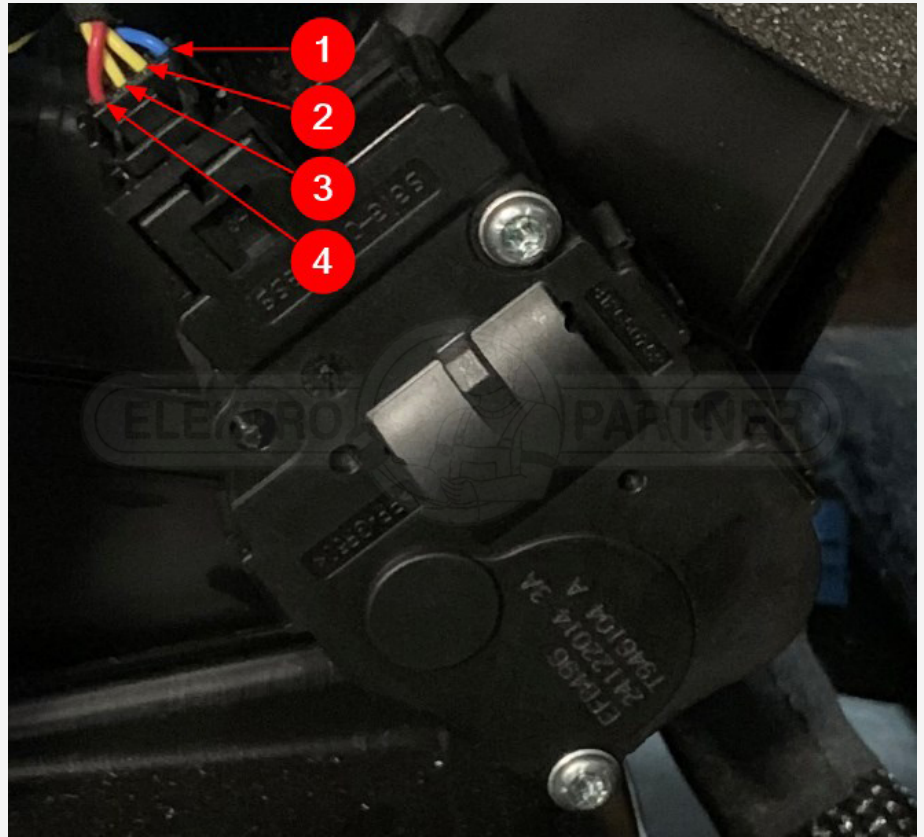
The colours of the wires vary, but the Linbus wires are always the middle 2 wires.

- 1. Ground**
- 2. Linbus in**
- 3. Linbus out**
- 4. Positive 5V**

The resistance between pin 2 and 3 must be higher than 20 Kohm.

**Also measure the wires to see whether there is a short circuit to ground.
Wires may touch ground under the dashboard and thus destroy the Linbus signal.**
