RADIATORS, INTERCOOLERS, CONDENSERS - LARGER SIZE HEAT EXCHANGERS WITH MOUNTING BRACKETS APPLYING SHOCK-ABSORBING BUSHING.

TRUCK AND SOME LIGHT VAN / PASSENGER CAR APPLICATION

PROBLEM PREMATURE RADIATOR/HEAT EXCHANGER FAILURE

EXCESSIVE VIBRATION > LEADS TO RADIATOR COMPONENTS BURSTING THUS CAUSES LEAKS

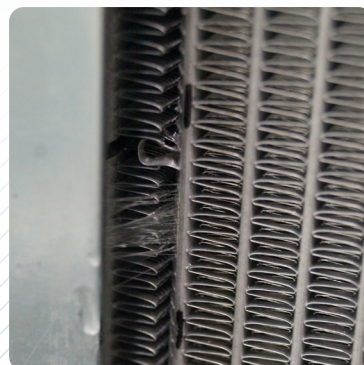
Shock-absorbing bushing may apply various design. Majority are inexpensive and easy to install.

Whenever installing a larger size heat exchanger (radiator / intercooler / condenser) in a truck or a commercial vehicle, make sure, the fitting requires shock-absorbing bushings.

Do not reuse old busing by the part replacement as the rubber may be worn thus its shock absorbing ability is lowered significantly.

Fitment bushings are typically inexpensive and a simple rubber/metal-rubber design components. There are easy to install and ensure the heat exchanger secure, vibration-free fitment thus a long, trouble-free operation
