THEME COMPONENT INSTALLATION

NON-PRODUCT RELATED TURBO FAILURES

PROBLEM FEW SPECIFIC TURBO MODELS HAVE ISSUES, RELATED TO INSUFFICIENT KNOWLEDGE AND WORKMANSHIP.

CAUSE IMPROPER LUBRICATION OF THE TURBO - OIL STARVATION CAUSED BY BLOCKAGES AND CARBON BUILD-UP

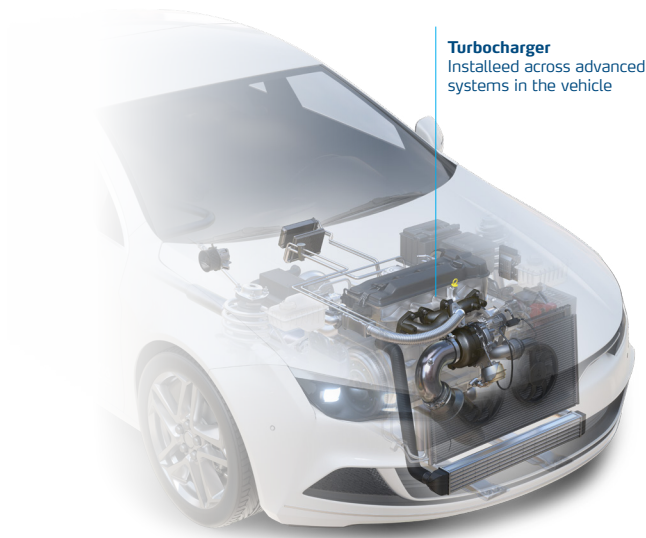
A. TURBO IS PART OF MANY COMPLEX SYSTEMS

A turbocharger is part of several complex systems in a vehicle, namely the exhaust system, air intake system, cooling system, engine lubrication system and engine management & electrical systems.

This means that a turbo can malfunction due to a variety of reasons and from the influence of other faulty components across the systems, such as defective oil feed components, EGR valve, intercooler etc.
