THEME COMMON FAILURES IN AC SYSTEM SERVICING ADDITIVES HARMFUL TO THE COMPRESSOR

PROBLEM IRREVERSIBLE AC COMPRESSOR DAMAGE OCCURING SHORTLY AFTER COMMON SERVICE PROCEDURES

CAUSE IMPROPER USE OF AC SYSTEM ADDITIVES IMPAIRING THE COMPRESSOR LUBRICATION

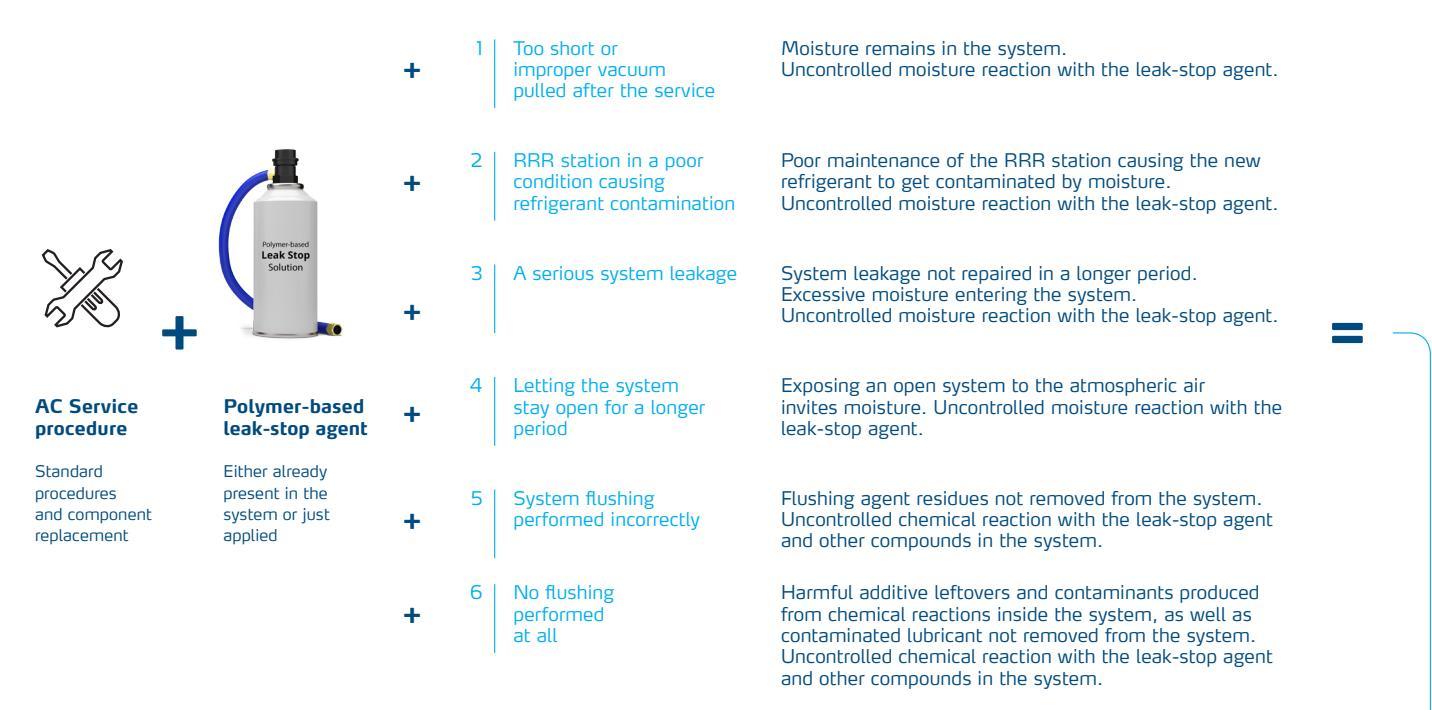
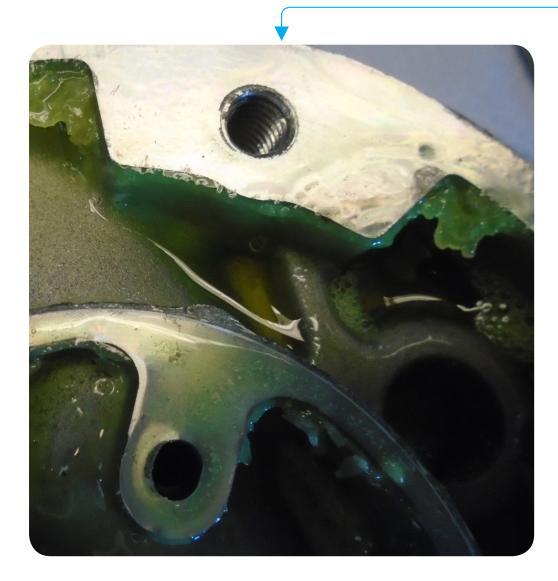
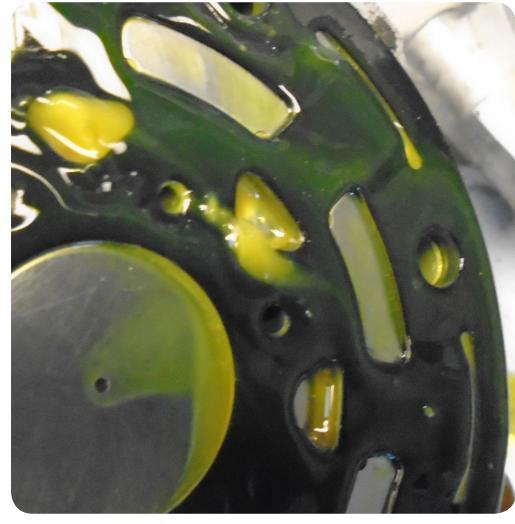
B.1. Possible Failure Scenarios Polymer-based leak-stop agents

Jelly-like or crystallized sticky substance inside of the compressor and other system components

Uncontrolled moisture reaction with a leak-stop agent. The agent reacts excessively, and instead of treating small leakages causes an uncontrolled crystallization. This causes stoppages inside the compressor and inside other components of the system.

Inner blockages - wobble plate / pistons / valves / ECV/MCV stuck:

- abnormal operation mainly lack of performance
- no or limited displacement control
- piston/cylinders cannot move in the proper way

Impaired lubrication leading to overheating thus the compressor to seize

Inner flow blockages causing overpressure and overheating - limited flow through condenser/evaporator channels

Inner flow blockages causing improper operation - EXV valve/expansion device stuck

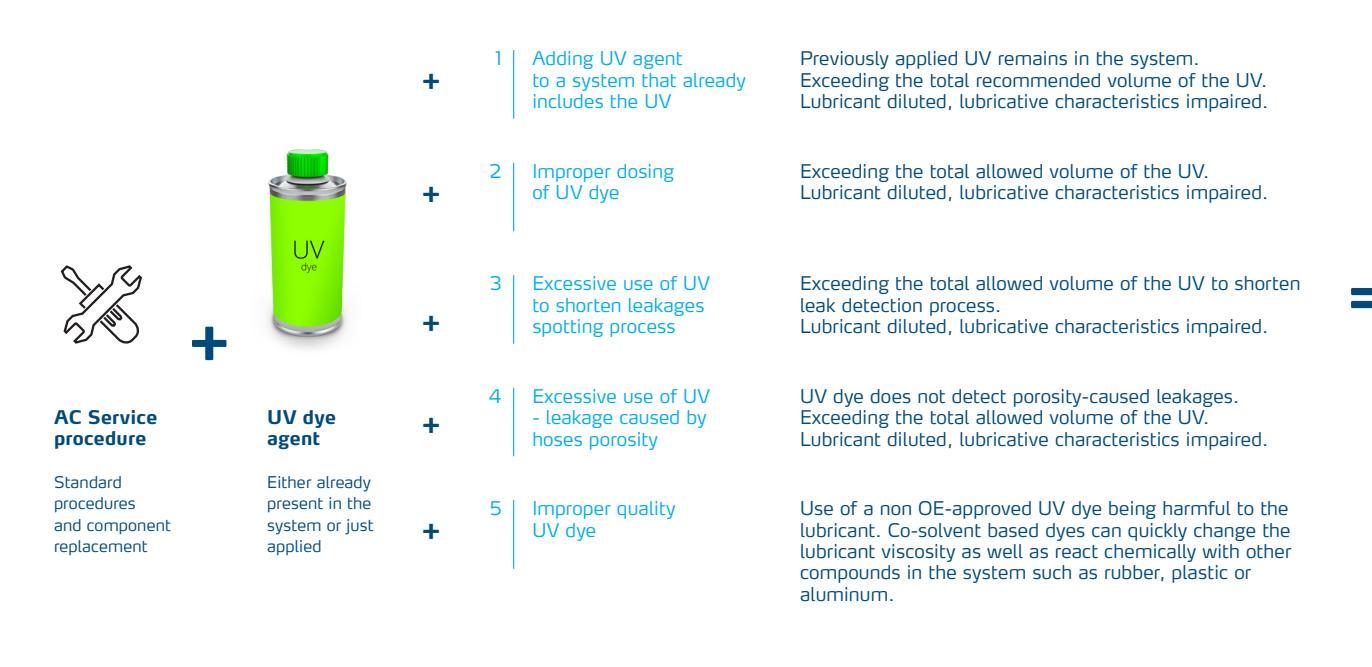
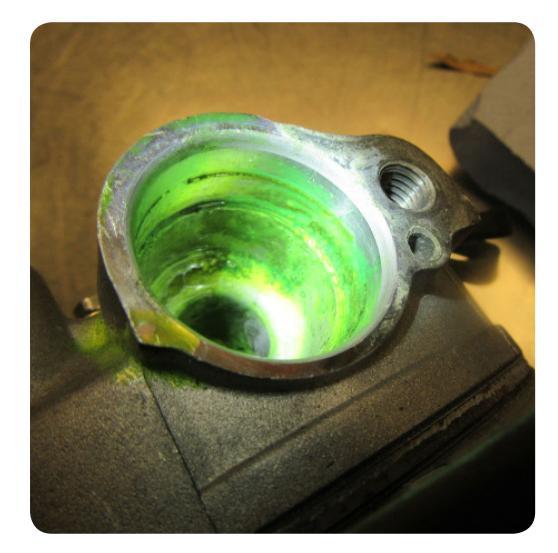
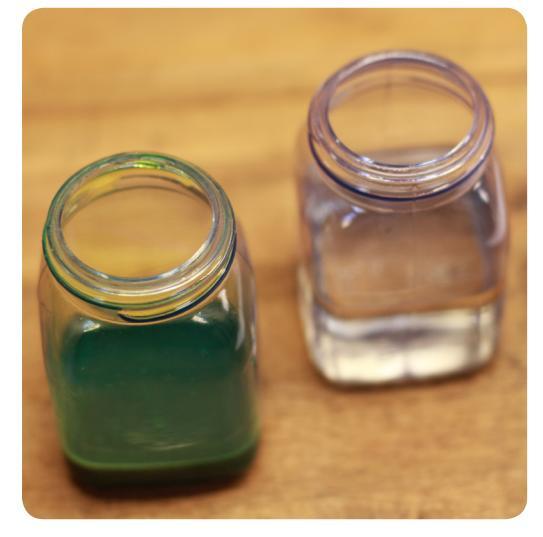
B.2. Possible Failure Scenarios UV dye

Oil tapped out of AC compressor characterized by an intense green or a dark green color indicating an extensive amount of UV dye in the system.

Visibly intense green color spotted on compressor charge/discharge ports or other couplings of the AC loop.

An extensive amount of UV dye causes oil to dilute, thus impacting its lubricative parameters, and viscosity and density specifically. The system and its components, especially the compressor, are not lubricated properly.

Poor or improper lubrication leads to:

- Increased frictions thus seizure
- Ovepressure overheating
- Overheating seizure
- Complete breakdown of the AC compressor

NB! Overheating of the oil can also lead to carbonization and creation of solid particles that further contaminate the compressor valves and limit flow and regulation of the compressor.

UV Dye	Always use an OE approved and co-solvent free dye. Do not exceed the amount prescribed by the dye manufacturer to be added to the system. As the dye mixes and travels along with the lubricant, dosing the additive always refers to the total lubricant volume defined for the given vehicle model by its manufacturer. Flush the system to remove the lubricant and UV dye completely from the system. Notice that the automatic recovery performed by a RRR station cannot remove all of the lubricant. Flushing and charging a completely empty system is the only way to determine the correct amount of oil with dye for the given vehicle.
Leak-stop agents	Apply only additives approved by OE. Always conform with the additive dosing instructions and with the vehicle manual/OE bulletin. Avoid using polymer-based agents or agents reactive to moisture.
